LOOKOUT POINT CAUSEWAY RESILIENCY ASSESSMENT

Town Lands Committee
Harpswell, Maine

November 20, 2020

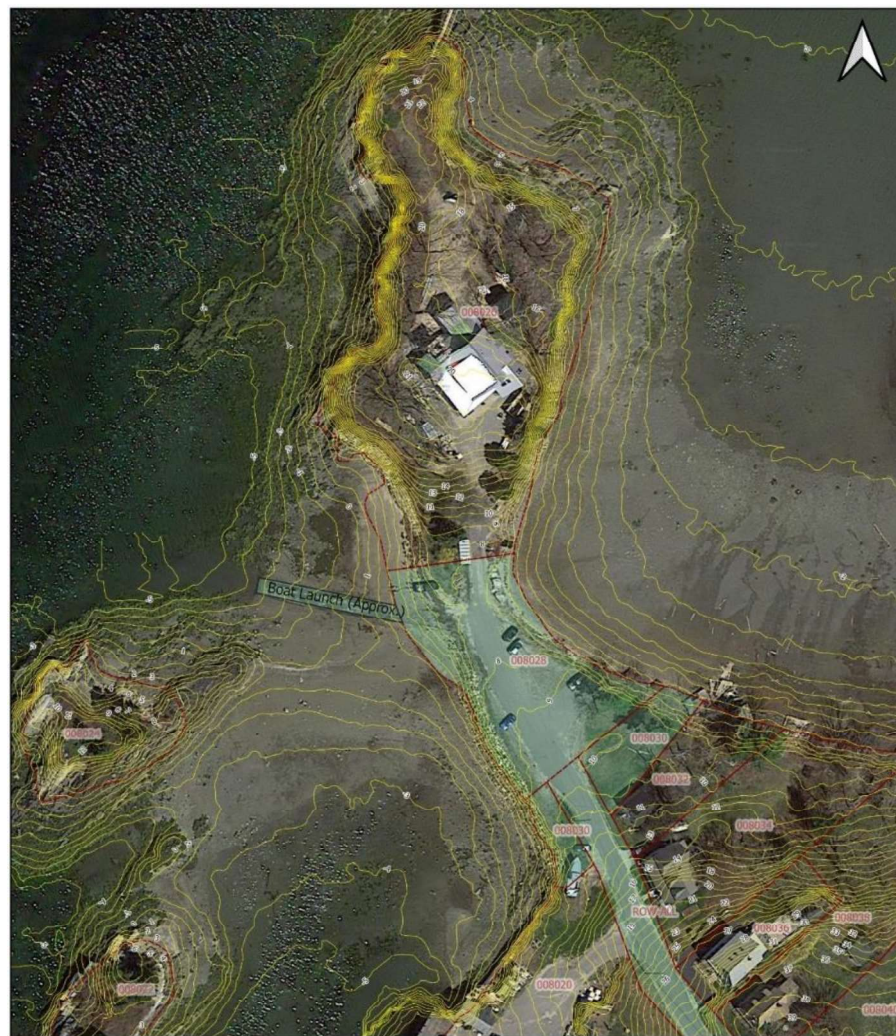
Figure 2: Lookout Point site map and elevation contours.

Refer to the photographs located in *APPENDIX A SITE PHOTOGRAPHS* (Clockwise- North to South) and *Figure 2* below. The light green hatching shows the location of Town property that includes the boat launch and parking/turn-around areas. The point and islands set offshore from the launch ramp are privately owned. The site features stunning views of Casco Bay and is popular with Harpswell residents. It is used as follows:

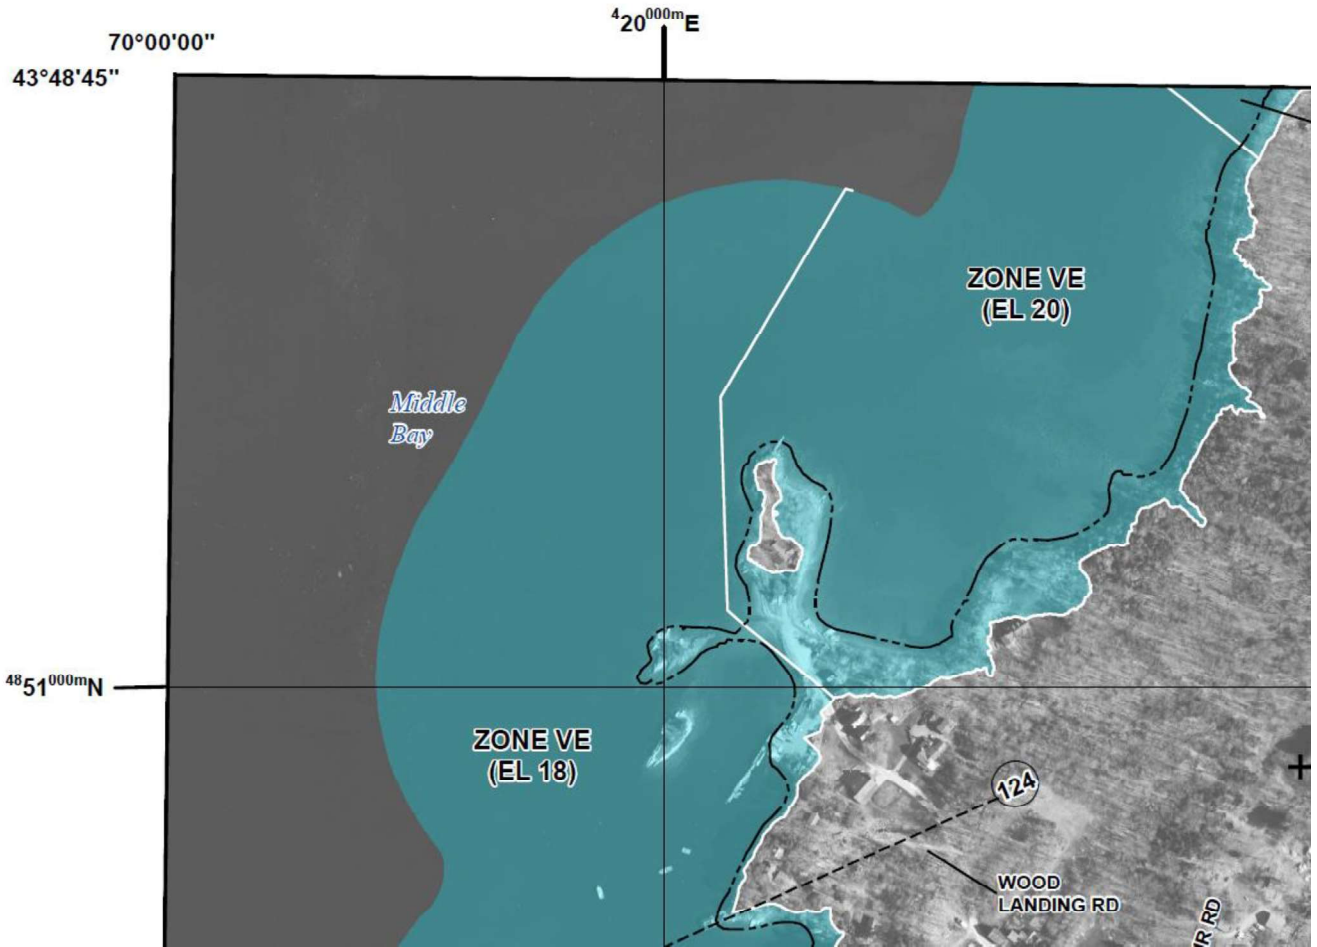
Figure 9: Subset of FEMA Preliminary FIRM Panel 23005C0586F.

Figure 9 shows a subset of FEMA Firm Panel 23005C0586F, with the whole panel given in Appendix A. Of note in *Figure 9* are the VE Zones to the east and west of Lookout Point with BFEs of 20 and 18 feet, respectively. The nearest transect to lookout point is Transect 124, and is just 700 feet to the south, providing a trustworthy analysis point for wave plus flood hazard, as shown in *Table 3*.

The base flood elevations shown in *Figure 9* are well above the elevation of the causeway, with nothing short of strategic retreat from the site being able to protect against the 1% design flood levels. The base flood elevations shown in *Figure 9* are a combination of the still water level due to storm surge plus the effects of wave height, overtopping, and runup. The still water levels from the FEMA Flood Insurance Study at Transect 124 are given in *Table 3*.

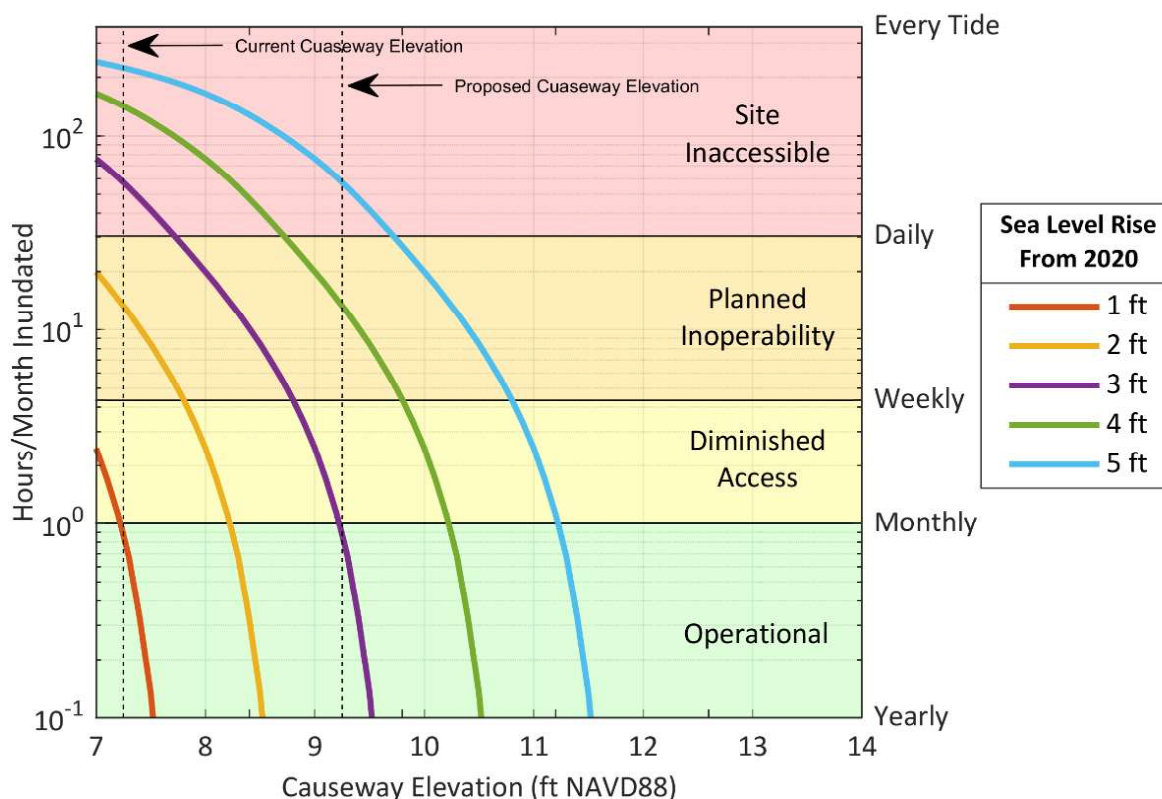
Figure 10: Inundation rates vs. causeway elevation for different SLR ratios. Also shown are the performance based operational statuses from Table 2 and the current and proposed causeway elevations. Note logarithmic y-axis.

The risk of the causeway and boat ramp flooding given current sea levels is limited to “nuisance” flooding, where the boat ramp is inundated at most several times a year during winter storms. Protecting the site against the base flood defined by FEMA is unattainable. However, careful planning and proper use of materials and construction methods can allow the causeway and boat ramp to inundate gracefully and limit damage in the case of the design flood. *Figure 10* below shows the decision process for obtaining the design causeway elevation of 9.25 ft. *Figure 10* displays the inundation rates vs. causeway elevations for various sea level rise scenarios. Also shown in the figure are shaded regions of performance based operational statuses from *Table 2*, and the current and recommended causeway elevations. The basis for the 9.25 ft suggested causeway elevation is derived from by taking the intersection of the 3 ft sea level rise curve and the boundary between diminished access (~1 hour per month of inundation) and fully operational (<1 hour per month of inundation). At this point, it is expected that the causeway will be inundated less than once per month from normal tidal cycles and will maintain diminished access up to four feet of sea level rise.

The improvements proposed below will protect the causeway against “nuisance” flooding that will become more common in the future to help maintain access to the boat launch. The recommended improvements and their benefits to Lookout Point include:

1. Raise the elevation of the causeway to at least 9.25 ft (NAVD88)
 - Prevents against nuisance flooding

- Maintains 2020 operability levels of the boat launch up to 3 feet of sea level rise
- Proper construction prevents against damage during storm flood events

- 2. Stone riprap on both east and west sides of dirt road to meet natural grades
 - Limits erosion due to wave action during annual storms
 - Potentially limits catastrophic damage during design flood

- 3. Regrade the boat ramp to meet the new causeway elevation
 - Provides easier access to boaters
 - Meets proposed causeway elevation
 - Provides space for riprap to be placed to protect boat ramp from wave damage

- 4. Replace asphalt boat ramp with precast concrete planks
 - Prevents cracking and pavement loss during nuisance floods
 - Provides a more robust launch area for potential use as emergency access point

- 5. Utilize living shoreline improvements such as oyster baskets to reduce wave action in subtidal areas to the east and west of the point
 - Lessens wave action on the causeway and boat ramp to decrease erosion and damage
